CBCT In Treatment Planning Of External Cervical Resorption: A Case Series

Ali Fatemi, DDS, MSc, FRCD(C); Yosef Nahmias, DDS, MSc

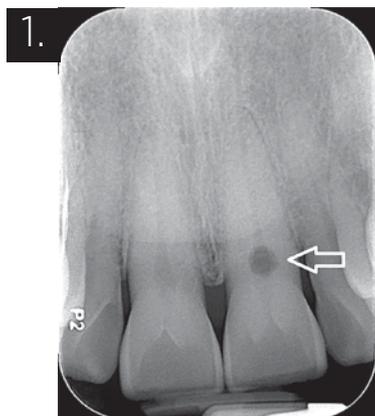
Pre-operative radiograph of tooth 2.1, showing resorption at cervical area.

Case #1: A 73-year-old male was referred to our office due to a radiolucent area on tooth 2.1. His medical history showed hypertension, diabetes, and heart murmur. In the referral, it was mentioned that there is an internal resorption defect on tooth 2.1. Clinical examination revealed slight tenderness on palpation of attached gingiva of this tooth with sensibility tests within normal limits. There was no mobility and probing depths were normal. Periapical radiograph showed a circular radiolucent area on cervical third of root at the level of crestal bone (**Figs. 1 & 2**).

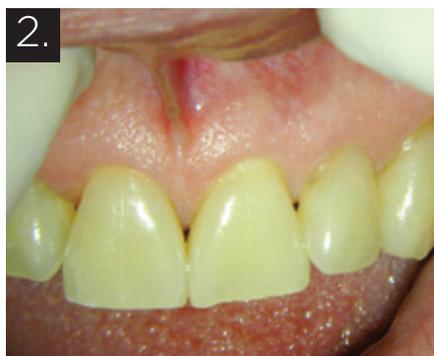
Clinical photograph of tooth 2.1, depicting normal clinical view.

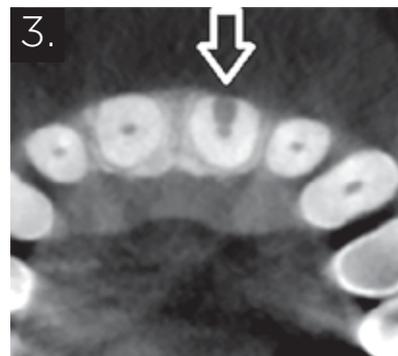
Axial view of CBCT image of tooth 2.1, illustrating the resorptive defect.

the root of tooth 21 exhibited external resorption involving the coronal third of the root. This resorption extended from the surface of the tooth to the depth of the root canal system, but no evidence of periapical pathology was associated with tooth 21. The resorptive defect was well-defined and confined to the supracrestal portion of the root, which suggested it might be amenable to repair (Figs. 3 & 4).

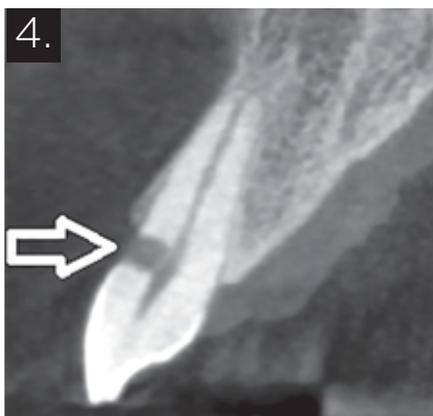
Coronal view of CBCT image of tooth 2.1, showing supracrestal position of resorption.

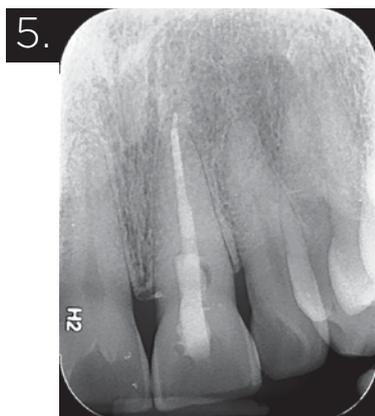
Post-operative radiograph of tooth 2.1 after completion of root canal therapy.

Treatment options were presented as either extraction and replacement with implant, or root canal therapy followed by surgery to remove the resorbing tissue and seal the defect. Patient was willing to try to save the tooth, and took the second option. Root canal treatment was completed on tooth 2.1 (Fig. 5). Surgery was also completed and facial defect was cleaned, and sealed with Geristore (Figs. 6-9A & 9B).

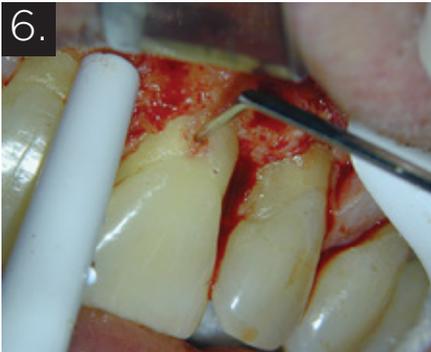
6. Intra-operative photograph of tooth 2.1 showing surgical exposure of the resorption.

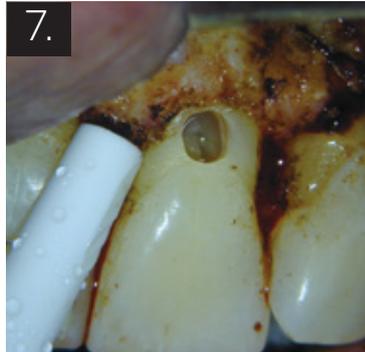
7. Intra-operative photograph of surgery on tooth 2.1 after removal of resorptive tissue and cavity preparation.

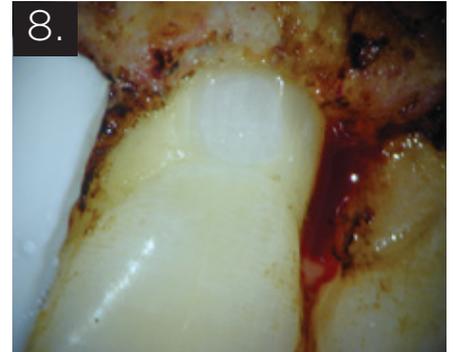
8. Intra-operative photograph of surgery on tooth 2.1 depicting restoration of defect using Geristore.

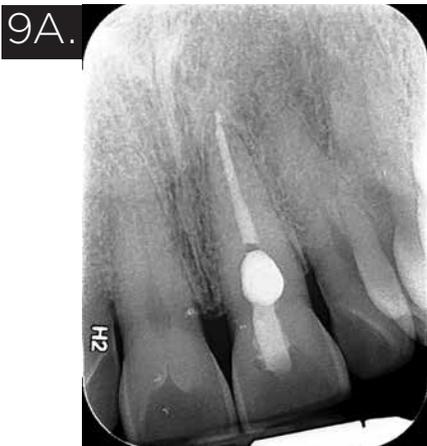
9A. Final radiograph of tooth 2.1 after completion of surgery.

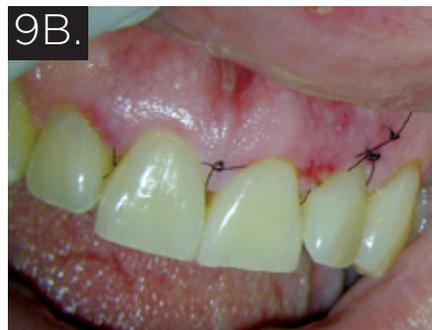
9B. Clinical Photograph three days after the procedure at the suture removal appointment, note remarkable healing of the soft tissues.

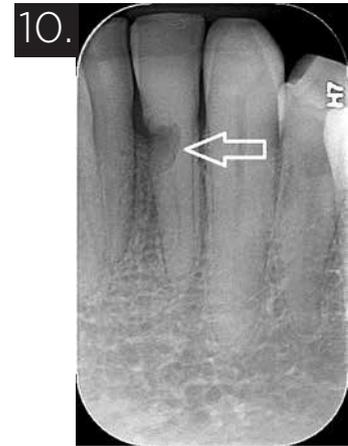
10. Pre-operative radiograph of tooth 3.2, showing resorption at cervical area.

Case #2: A 52-year-old male was referred to our practice by his hygienist after a recent tooth cleaning. There was slight tenderness on buccal gingiva of tooth 3.2. On the periapical radiograph a large radiolucency was noted involving cervical area of tooth 3.2 (Fig. 10). The patient was advised that there is an external cervical resorption lesion that has eroded tooth structure at gum level. He was informed that prognosis for treatment of this is unpredictable and if he wants to try to save the tooth, we will need a CBCT to investigate the extent of the lesion and feasibility of repair.

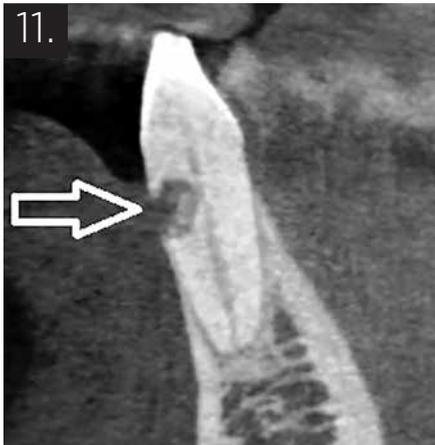
Coronal view of CBCT image of tooth 3.2, illustrating the resorptive defect.

CBCT image showed that the mesio-buccal surface of tooth 3.2 exhibited a well-defined area of external resorption, which was limited to the coronal third of the root.

Although this resorptive defect abutted the root canal system, no periapical pathology was present. The presence of subcrestal extension suggested this defect may not be amenable to repair (Figs. 11 & 12).

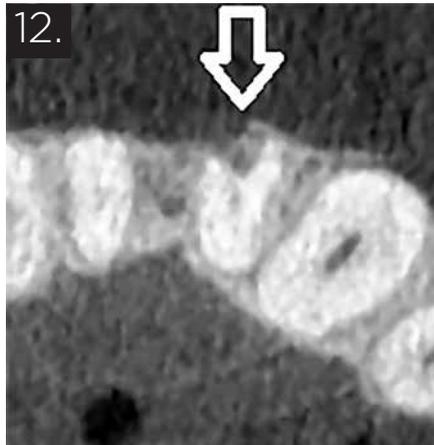
Axial view of CBCT image of tooth 2.1, showing the position of resorption.

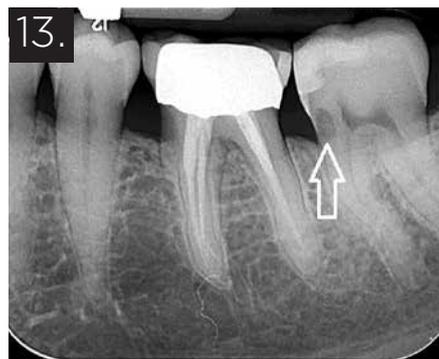
Pre-operative radiograph of tooth 3.7, showing resorption at mesial interproximal area, coronal to crestal bone.

Case #3: A 47-year-old female was referred for a radiolucent area on tooth 3.7 (Fig. 13). The tooth was asymptomatic and all sensibility tests were within normal limits. She was already referred for CBCT, and external resorption was present on the mesial surface of tooth 37 at the level of the cemento enamel junction (Figs. 14 & 15). The lesion was confined to the supra-crestal region of the tooth. The pulp chamber of the tooth was not affected. The periphery of the defect was well-defined, and it seemed to be amenable to repair. The periapical bone appeared normal.

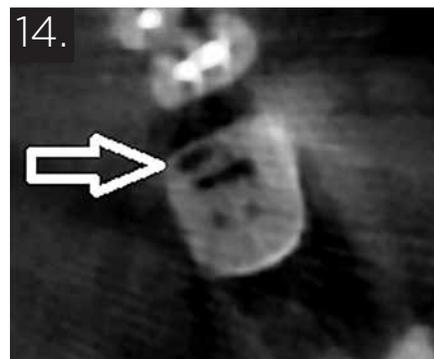
Axial view of CBCT image of tooth 3.7 illustrating the resorptive defect, involving mesial interproximal surface.

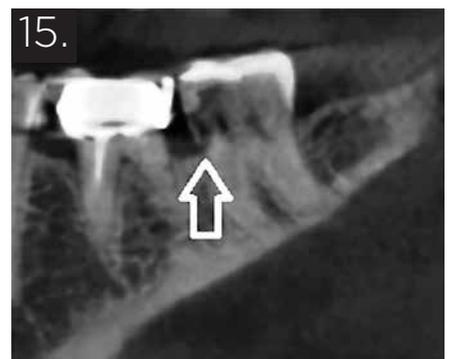
Coronal view of CBCT image of tooth 3.7, illustrating the resorptive defect at level of alveolar crest.

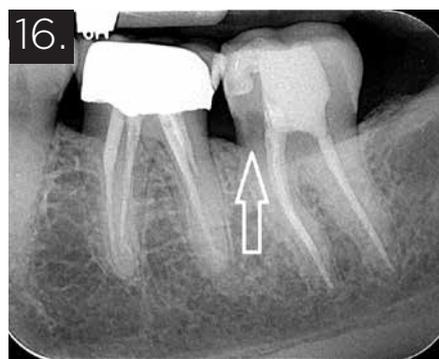
Post-operative radiograph of tooth 3.7 after completion of root canal therapy.

The options of orthograde root canal treatment, followed by a crown lengthening surgery to remove the lesion, and placement of crown, or extraction and replacement with implant were presented. Patient was motivated to try to save the tooth, although she was aware that the prognosis was questionable. Root canal treatment was done on tooth 3.7 followed by initial crown preparation, sealing the defect, and placement of temporary crown by her dentist. Crown lengthening surgery was rendered and the temporary crown was re-cemented. Final crown preparation and fabrication was postponed until periodontal healing (Figs. 16 & 17).

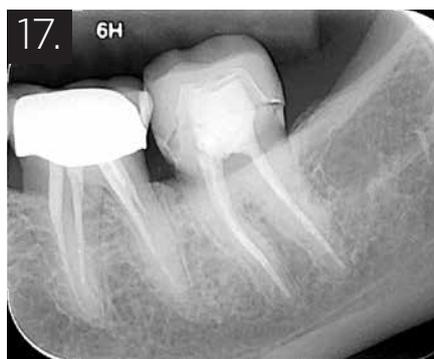
Post-operative radiograph of tooth 3.7 illustrating restored defect and temporary crown placed.

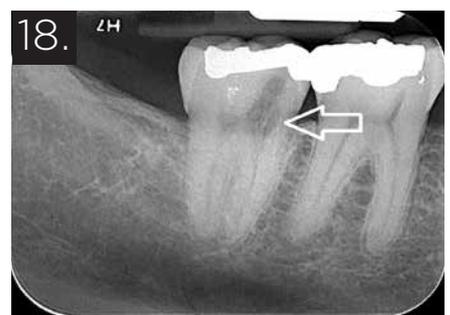
Pre-operative radiograph of tooth 4.7, depicting resorption at cervical third of root and pulp chamber.

Case #4: This patient was a 44 year-old man referred due to a resorptive defect seen on periapical radiograph of tooth 4.7 (Fig. 18). Tooth was slightly sensitive in chewing. Sensibility tests were within normal limits. He was sent for a CBCT to

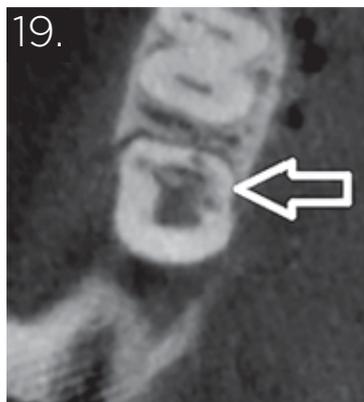
19. Axial view of CBCT image of tooth 4.7 illustrating the resorptive defect, involving mesial Interproximal and lingual surfaces.

better investigate the lesion and to assess the feasibility of treatment. Extensive external resorption was evident within the crown and coronal third of the mesial root of tooth 4.7. The resorption appeared ill-defined and continuous with the root canal system of this tooth, and appeared to extend slightly subcrestally. There was no evidence of periapical or periradicular pathology in tooth 47. The position of this resorptive defect suggested that it may not be amenable to repair (Figs. 19 & 20).

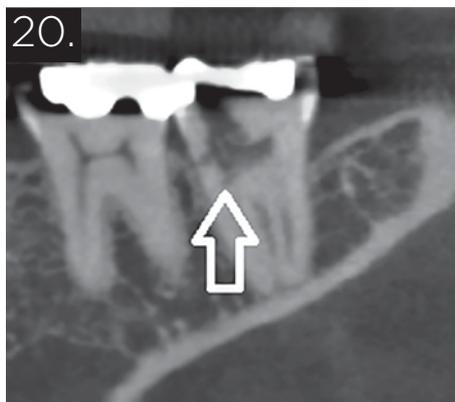
20. Coronal view of CBCT image of tooth 3.7, illustrating infracrestal position of resorption.
